# LiDAR

## What do you do with all that data?

Created by: Jarrod C. Harper  
CAD/GIS Manager  
(802)-770-6223 / [jharper@velco.com](mailto:jharper@velco.com)

# Scope of Project

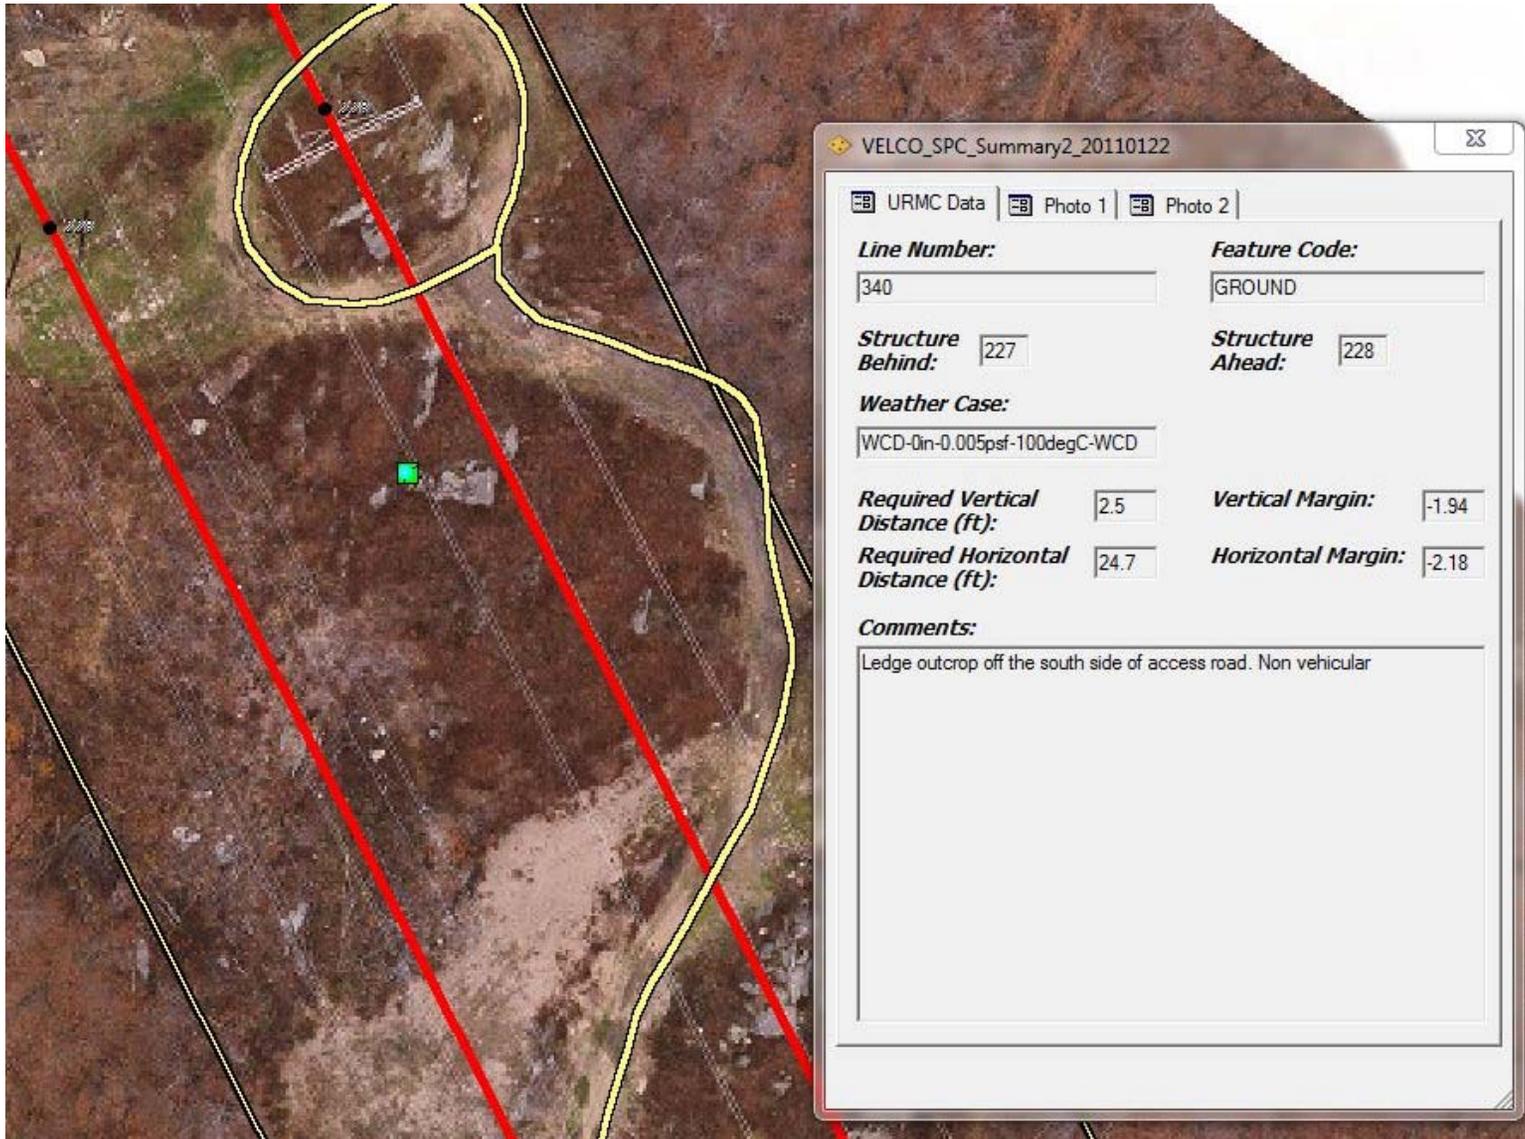
# Data Validation: Asset Maintenance

<b>Line Number:</b>	340	<b>Feature Code:</b>	GROUND
<b>Structure Behind:</b>	227	<b>Structure Ahead:</b>	228
<b>Weather Case:</b>	WCD-0in-0.005psf-100degC-WCD		
<b>Required Vertical Distance (ft):</b>	2.5	<b>Vertical Margin:</b>	-1.94
<b>Required Horizontal Distance (ft):</b>	24.7	<b>Horizontal Margin:</b>	-2.18

**Comments:**  
Ledge outcrop off the south side of access road. Non vehicular

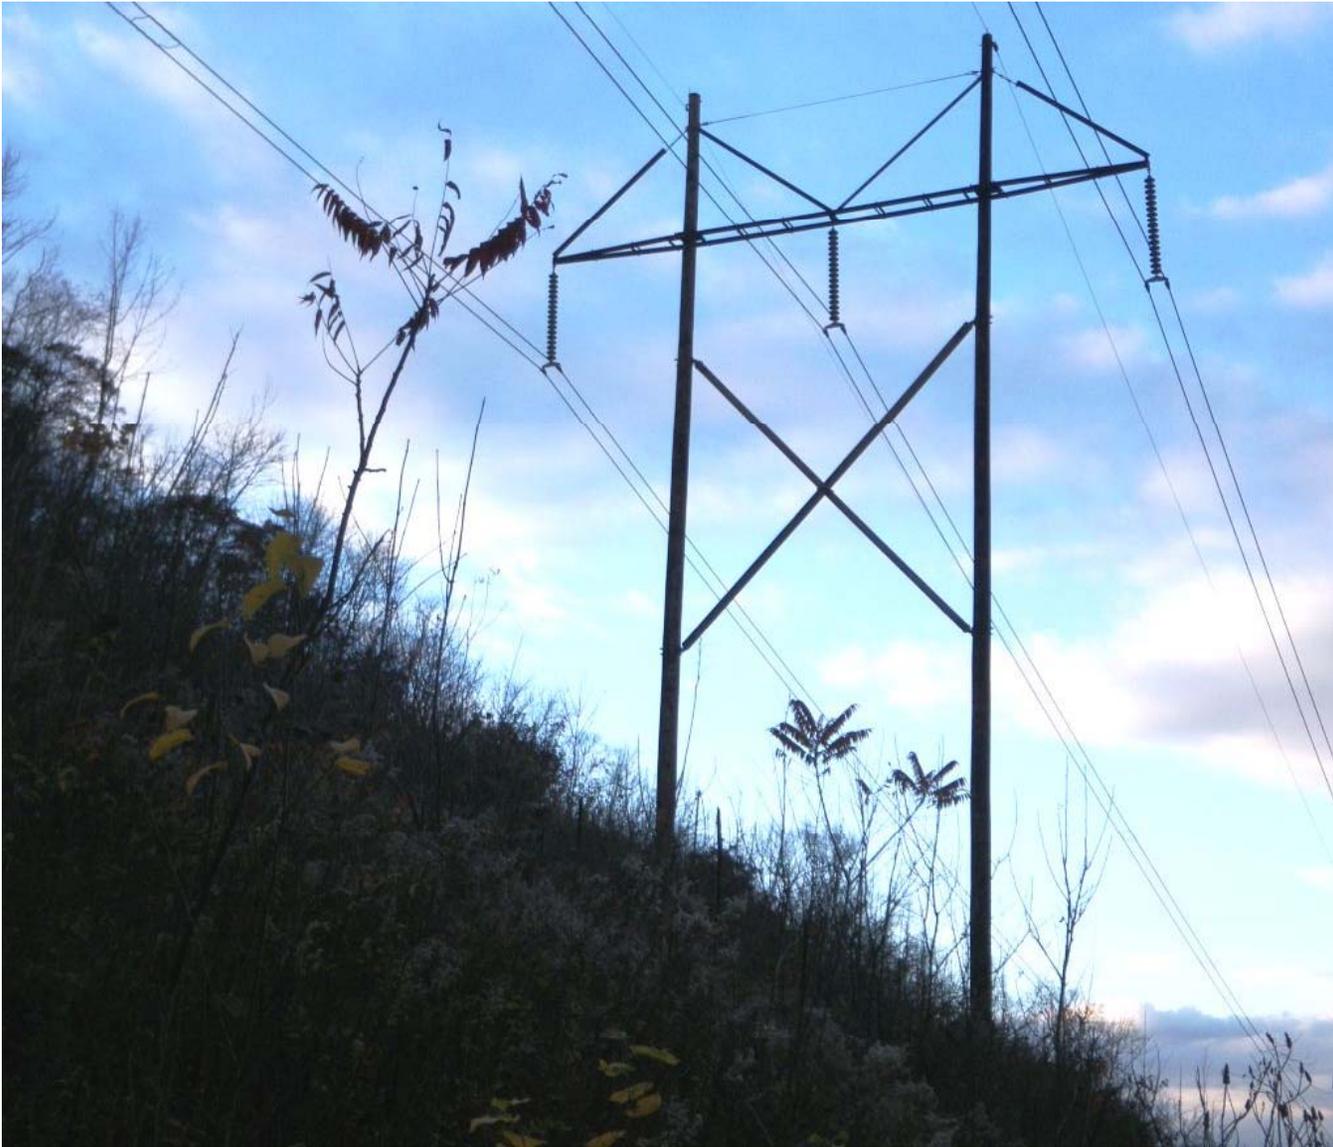
# Misclassification Examples: Vehicular

- **Misclassification of LiDAR Ground Points**
  - **Conductor Buffer Widths**
  - **Misinterpretation of Data**
  - **Software Limitations**
- 
- **Resetting the conductor buffer widths to 2.5' reduced the total clearance points by 8.4%**
  - **Of the lines reviewed in 2011, 15% of the vehicular clearance points were reclassified to pedestrian.**
